# Manhole Inspection Summary

Manhole # S67U\_\_003MH

Insp Date: **3/7/08 10:33 AM**

**Location** Address: **6207 Eastbourne Ave.**

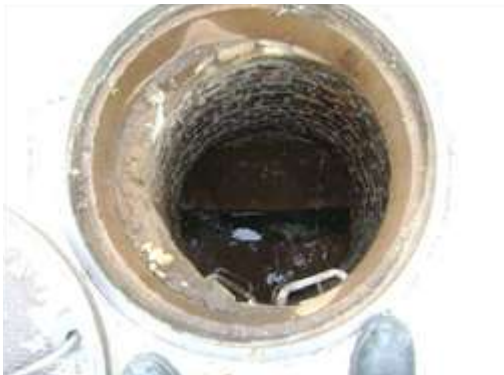
Defect 1

**Frame** Offset: **2** (in.) Condition: ☒ Sound ☐ Cracked ☐ Leaks

Frame offset defect

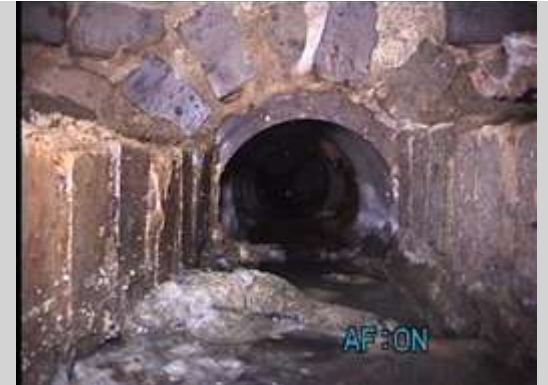
12 O'Clock Outflow

8 in. Circular Gravity Sewer  
Pipe Out @ 12 O'Clock

Pipe Height: **8.4** (in.) Rod and Bar (Angled)  
Pipe Material: **Clay** ☐ Pipe Lined  
Invert Depth: **9.25** (ft.) Flow Characteristics: **Slow**  
Deposits: ☒ None ☐ Mud ☐ Sludge ☐ Debris ☐ Grease  
Silt Depth: (in.) Deposits Extent:  
Infiltration: **None** Pipe Seal Cond: **Sound**

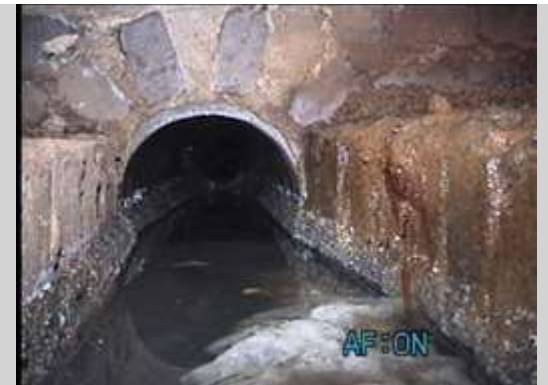
6 O'Clock Inflow

8 in. Circular Gravity Sewer  
Pipe In @ 6 O'Clock

Pipe Height: **8.4** (in.) Rod and Bar (Angled)  
Pipe Material: **Clay** ☐ Pipe Lined  
Invert Depth: **9.46** (ft.) Flow Characteristics: **Slow**  
Deposits: ☒ None ☐ Mud ☐ Sludge ☐ Debris ☐ Grease  
Silt Depth: (in.) Deposits Extent:  
Infiltration: **None** Pipe Seal Cond: **Sound**
